West Lake Landfill Vicinity

Radiological Survey and Sampling

Final Report

Hazardous Waste Program
Federal Facilities Section
March, 2016

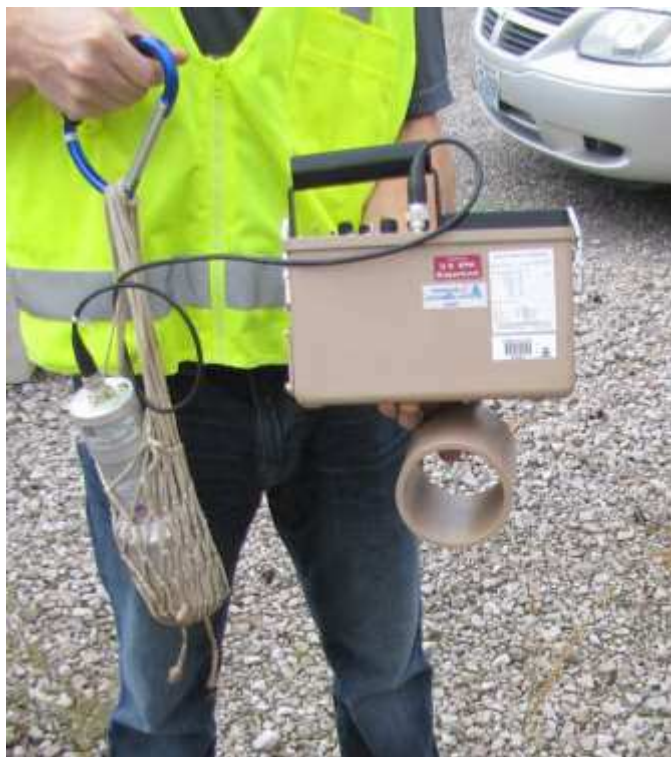
EPA Equipment Y: Ludlum model 2221 with 44-20 NaI Gamma Scintillator detector – This field equipment was brought by and periodically used by EPA personnel at some sampling locations(Photograph 1.)

Photograph 1: EPA Ludlum 2221 with NaI 44-20 detector and directional shield attachment (EPA Equipment Y)

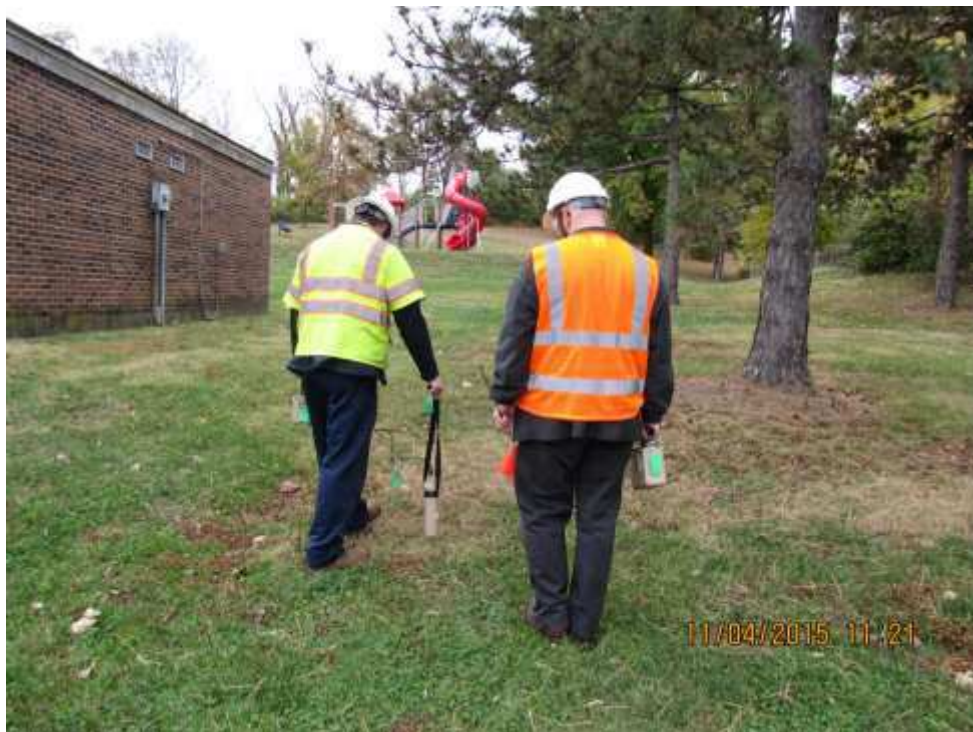
Procedure: For all soil and dust sample locations, equipment B or D was utilized to obtain instantaneous gamma readings where practical at sample areas identified in Figures 1 through 6. Locations within each area identified for soil sampling that had comparatively higher instantaneous readings were flagged for longer scans using equipment B. Some areas were surveyed several times, as shown in Table 4, during this sampling event. Photograph 2 shows an instantaneous gamma survey being conducted at Spanish Village Park.

Photograph 2: Gamma walkover survey conducted at Spanish Village Park

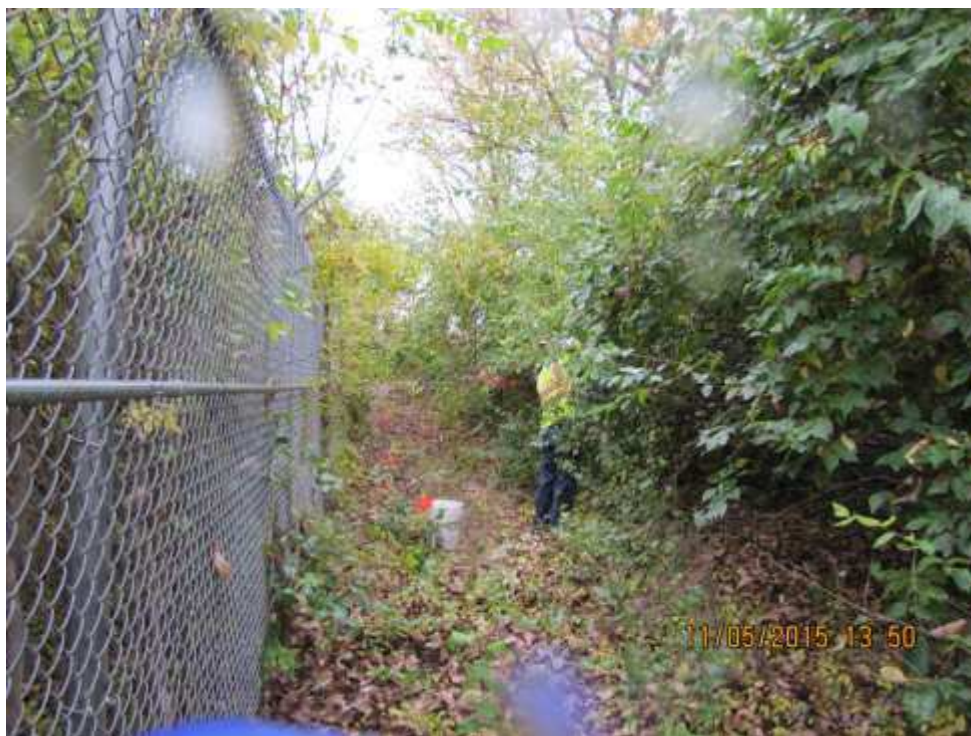
Total radionuclide activity in soil sample S09 were comparatively higher than total activity found in most other samples, and also exceeded EPA unrestricted use level for Th-230+232. Nearly half of the laboratory detected activity is associated with the Th-230 isotope. Soil sample S09 is located in proximity to soil sample S10 and dust sample D07, with all samples being on private property. Data suggest that RIM is present in sample S09, and further investigation in the area surrounding sample location S09 is warranted.

Photograph 3: One minute count being conducted on equipment B following gamma survey of immediate area. These locations are flagged in preparation of final soil sample location S09

1. Recommendation Requiring Additional Site Characterization; Soil Sample locations S09 & S10: Survey and sample data suggests that the area located immediately northwest of, and adjacent to OU-1 Area 2 requires additional characterization. The supporting data includes persistent comparatively higher values from gamma surveys, comparatively higher alpha and beta activity on dust swipe sample D07A, and soil sample results from S10, and S09 that exceed EPA's unrestricted use levels. These sample results can supplement on-going characterization activities by incorporation into any additional investigation conducted by EPA and the PRPs. This conclusion is consistent with the need for additional investigation identified in EPA's 2008 OU-1 Record of Decision (EPA 2008.)

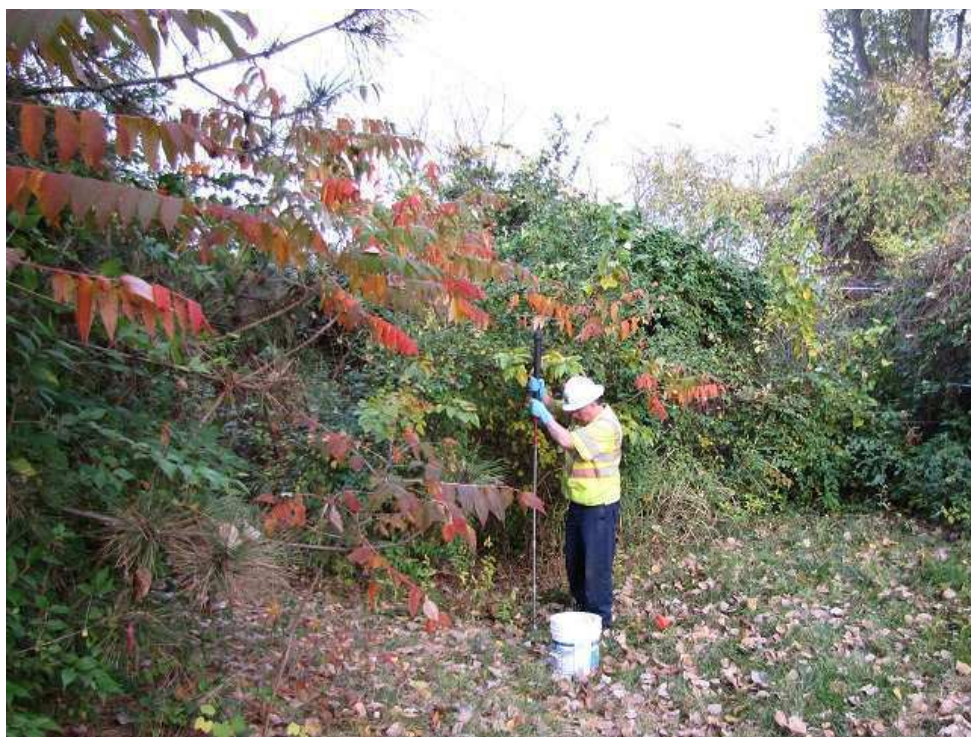
Photograph 4: Soil sampling with Split Spoon sampler

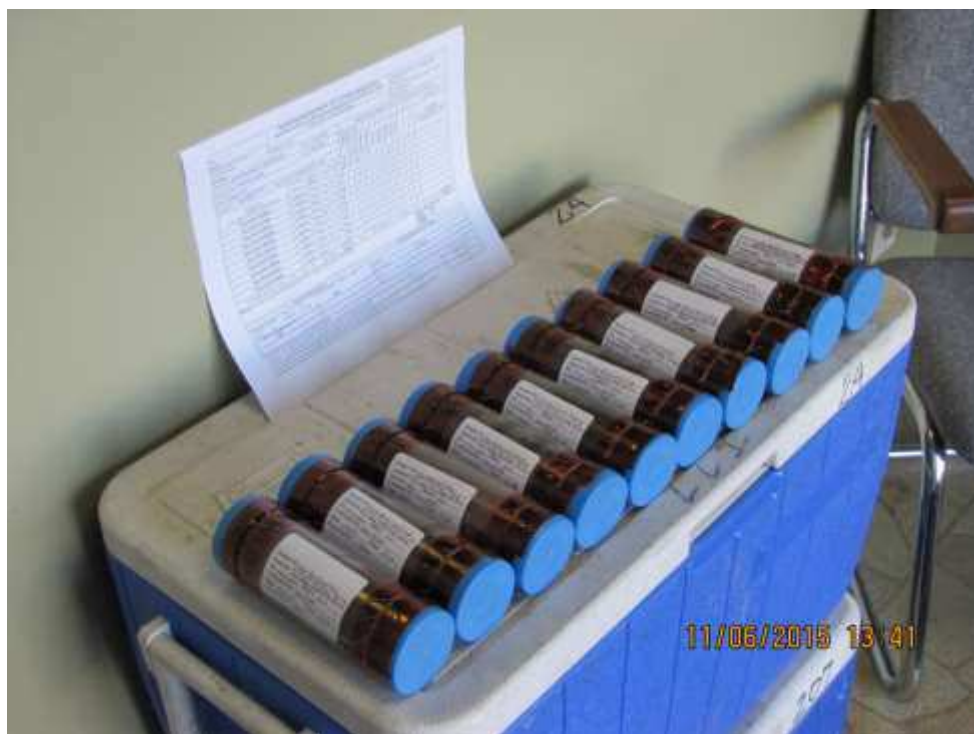
Photograph 5: Soil and sediment samples collected on November 4, 2015 being prepared for shipment

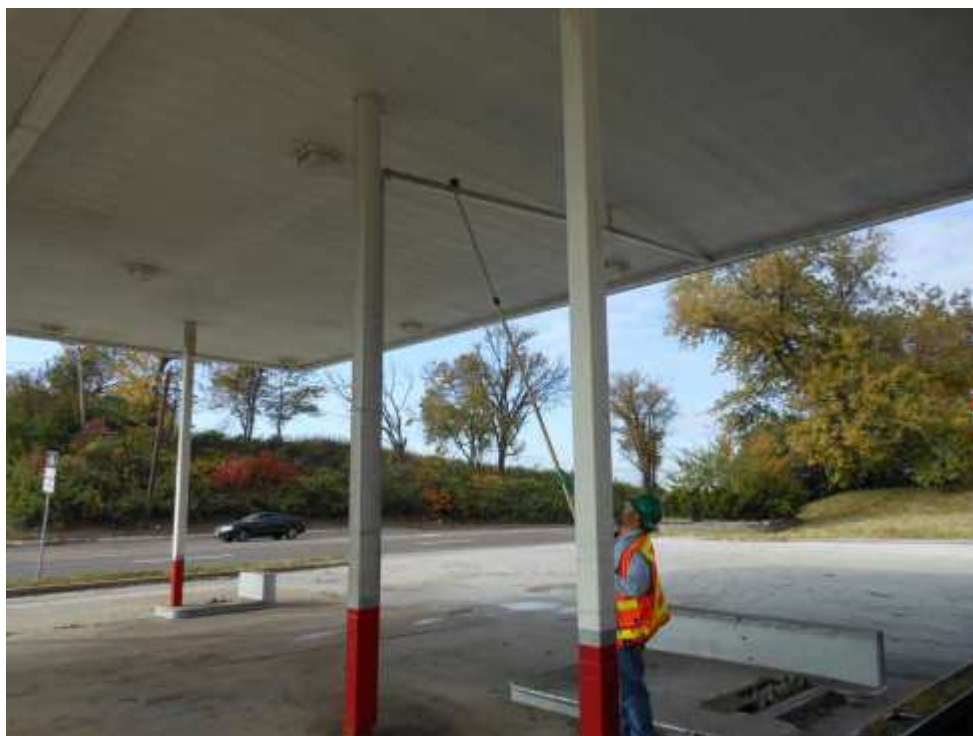
Photograph 7: Collection of dust swipe sample D02A
